**Flood Control Project Maintenance  
Levee Inspections**

**Fall 2019 Levee Maintenance Deficiency Summary Report**

**Sacramento River Basin**

**Sacramento Maintenance Yard Maintenance Area 0009**

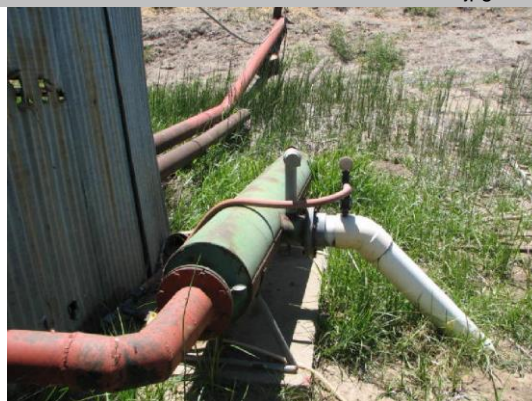
Photo 3 of 3 : UCIP\_FA\_2019\_5180\_7002.jpg

LM Start	15.04	Rating **	M	Issue No.	1830 (cont)	
LM End	15.04	Issue Type +	En	Location *		
Category	Supplemental			GPS Latitude/Longitude		
				Start	End	
Item	DRAFT DWR UCIP Field Study			38.400520 °	38.400520 °	
				-121.512300 °	-121.512300 °	
DWR ID	17429					
Comment Code						
Inspector Comment						
DS_ID:17429 FS_ID:5180 EP_NO: 6189 Repair Type: Non-Urgent Crossing Status: Found UCIP Comments: Need to determine if additional pipe on LS slope is discarded material or an additional pipe through the levee. FIELD_STRUCT_DESC: 5-inch pipe sleeved through 7-inch pipe through levee, 8.4 feet below crown. Annular space grouted, pump and gate valve in pump house on landward side (App. No. 6189 11/15/1968). Originally included in O+M manual (1955). 1-inch primer line runs to LS shoulder and 5-inch standpipe. FS Date: 6/25/2012 11:31:49 AM

Distribution system on LS toe.

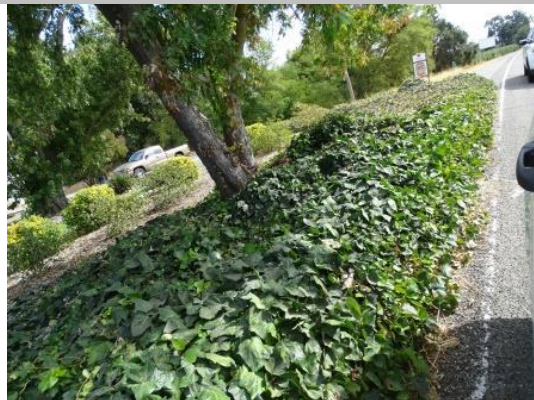
Photo 1 of 2 : FA\_2019\_MA0009\_201\_55\_20190904\_00021.jpg

LM Start	15.09	Rating **	M	Issue No.	55
LM End	15.09	Issue Type +	En	Location *	LS
Category	Earthen Levee			GPS Latitude/Longitude	
				Start	End
Item	Vegetation			38.399804 °	38.399804 °
				-121.512096 °	-121.512096 °
DWR ID	DWR_MA0009_01_s_2012_55				
Comment Code					
V6 : Landscaping					
Inspector Comment					
Ivy groundcover is not permitted and needs to be cleared.

View of ivy groundcover that is unsuitable and is blocking visibility. Fall 2018

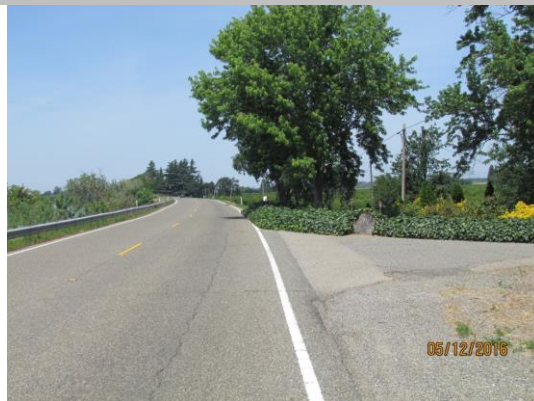
Photo 2 of 2 : FA\_2019\_MA0009\_201\_55\_20190904\_00022.jpg

View of the trees and ivy plants on the shoulder of the levee on the landward side looking upstream. Spring 2016.

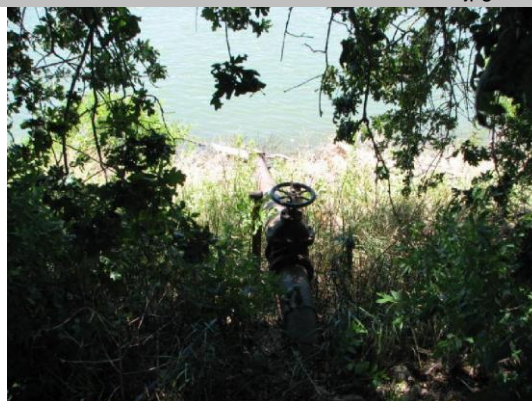
Photo 1 of 3 : UCIP\_FA\_2019\_5181\_7008.jpg

LM Start	15.19	Rating **	M	Issue No.	1831	
LM End	15.19	Issue Type +	En	Location *		
Category	Supplemental			GPS Latitude/Longitude		
				Start	End	
Item	DRAFT DWR UCIP Field Study			38.398340 °	38.398340 °	
				-121.511980 °	-121.511980 °	
DWR ID	17430					
Comment Code						
Inspector Comment						
DS_ID:17430						
FS_ID:5181						
EP_NO: N/A						
Repair Type: Non-Urgent						
Crossing Status: Found						
UCIP Comments: Gate valve on WS does not open or close.						
FIELD_STRUCT_DESC: 8-inch steel pipe through levee, 12.7 feet below crown. Joint pole, meter, 16-inch standpipe and pump on LS toe. Gate valve on waterward slope. 1-inch galvanized steel primer pipe runs parallel to 8-inch pipe on LS slope. Originally included in O+M manual (1955).						
FS Date: 6/25/2012 11:56:42 AM

Gate valve on WS slope.

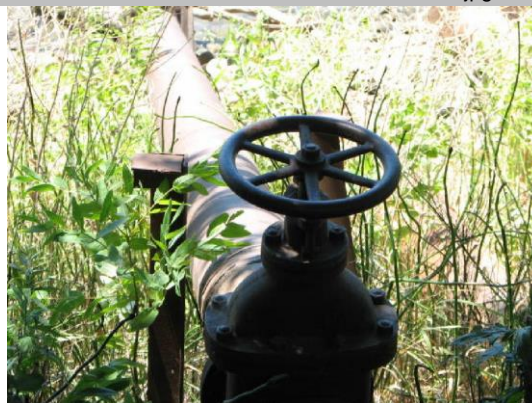
Photo 2 of 3 : UCIP\_FA\_2019\_5181\_7007.jpg

Close up of Gate valve on WS slope.

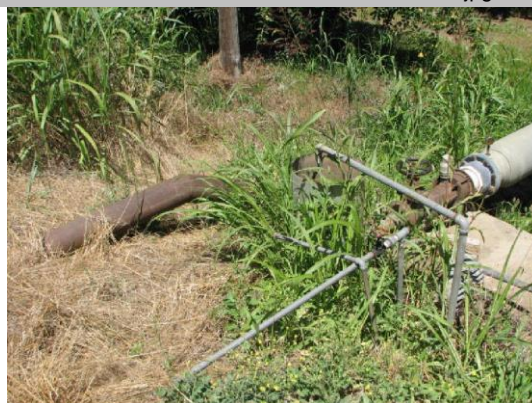
Photo 3 of 3 : UCIP\_FA\_2019\_5181\_7006.jpg

LM Start	15.19	Rating **	M	Issue No.	1831 (cont)	
LM End	15.19	Issue Type +	En	Location *		
Category	Supplemental			GPS Latitude/Longitude		
				Start	End	
Item	DRAFT DWR UCIP Field Study			38.398340 °	38.398340 °	
				-121.511980 °	-121.511980 °	
DWR ID	17430					
Comment Code						
Inspector Comment						
DS_ID:17430 FS_ID:5181 EP_NO: N/A Repair Type: Non-Urgent Crossing Status: Found UCIP Comments: Gate valve on WS does not open or close. FIELD_STRUCT_DESC: 8-inch steel pipe through levee, 12.7 feet below crown. Joint pole, meter, 16-inch standpipe and pump on LS toe. Gate valve on waterward slope. 1-inch galvanized steel primer pipe runs parallel to 8-inch pipe on LS slope. Originally included in O+M manual (1955). FS Date: 6/25/2012 11:56:42 AM

Pump, pipe, and appurtenances on LS toe.

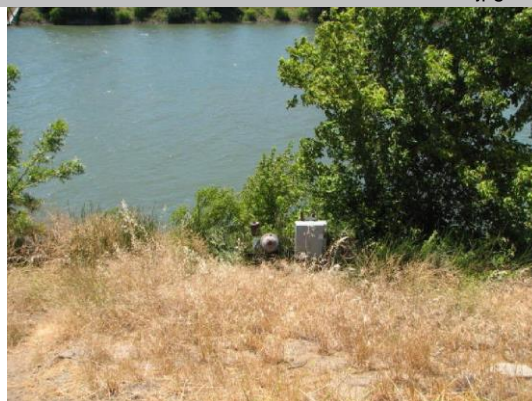
Photo 1 of 3 : UCIP\_FA\_2019\_53477\_20809.jpg

UCIP Comments: 08/24/2018 Everything appears to be the same as before. The intake pipe on the WS slope is in an unacceptable condition. A PVC pipe has been used to patch the deteriorating steel pipe, and it has been attached with duct tape. There are also metal zip ties along the PVC pipe section to hold it together. Tape was also used to cover another deteriorating section of the steel pipe. If the pipe is failing on the WS slope, then it's probably failing underneath the levee surface as well. Crossing remains "Urgent" due to the pipe integrity issues listed above. (A. McDonald - DWR UCIP)12/02/2016 Assumed same condition as last inspection--unable to verify damage reported during last inspection due to limited access to both WS and LS (steep slopes--safety issue). Crossing remains "Urgent" due to signs of sink hole/burrow activity visible along WS pipe alignment. Need to contact owner. Recommend internal integrity inspection be performed at this crossing to determine condition of pipe through the levee. (O. Magana - DWR UCIP)06/25/2012 2-foot deep 5-foot diameter sink hole over pipe at LS shoulder. Pipe has multiple repairs and leaks along water side slope. gate valve is in-operative. Pipe is likely failing internally. (W. Wylie - DWR UCIP)

FIELD\_STRUCT\_DESC: 12-inch steel irrigation pipe through levee, 17 feet below crown. Pump and gate valve on concrete stand box are located on the landside (LS) toe. Slant pump and 10-inch pipe sleeved into 12-inch pipe located on the waterside (WS) slope. A section of PVC pipe was used to patch the deteriorating steel pipe along the WS slope. The PVC pipe was attached to the steel pipe with duct tape and held together with metal zip ties. [Additional Reference(s): DWR Levee Log, 1991. USACE Sacramento O&M Manual Unit 111, May 1959 (River Mile 40.34)].

Slant pump on WS slope.

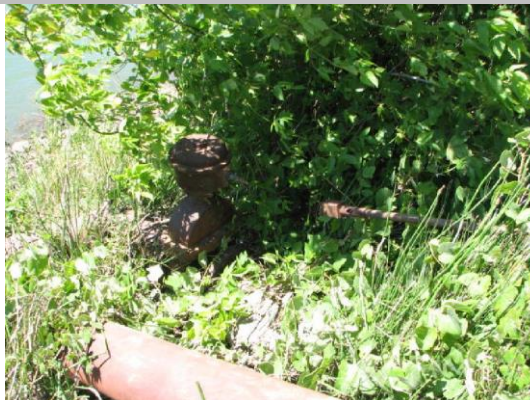
Photo 2 of 3 : UCIP\_FA\_2019\_53477\_20808.jpg

DS\_ID:17431  
FS\_ID:53477  
EP\_NO: N/A  
Repair Type: Urgent  
Crossing Status: Found  
UCIP Comments: 08/24/2018 Everything appears to be the same as before. The intake pipe on the WS slope is in an unacceptable condition. A PVC pipe has been used to patch the deteriorating steel pipe, and it has been attached with duct tape. There are also metal zip ties along the PVC pipe section to hold it together. Tape was also used to cover another deteriorating section of the steel pipe. If the pipe is failing on the WS slope, then it's probably failing underneath the levee surface as well. Crossing remains "Urgent" due to the pipe integrity issues listed above. (A. McDonald - DWR UCIP)12/02/2016 Assumed same condition as last inspection--unable to verify damage reported during last inspection due to limited access to both WS and LS (steep slopes--safety issue). Crossing remains "Urgent" due to signs of sink hole/burrow activity visible along WS pipe alignment. Need to contact owner. Recommend internal integrity inspection be performed at this crossing to determine condition of pipe through the levee. (O. Magana - DWR UCIP)06/25/2012 2-foot deep 5-foot diameter sink hole over pipe at LS shoulder. Pipe has multiple repairs and leaks along water side slope. gate valve is in-operative. Pipe is likely failing internally. (W. Wylie - DWR UCIP)

FIELD\_STRUCT\_DESC: 12-inch steel irrigation pipe through levee, 17 feet below crown. Pump and gate valve on concrete stand box are located on the landside (LS) toe. Slant pump and 10-inch pipe sleeved into 12-inch pipe located on the waterside (WS) slope. A section of PVC pipe was used to patch the deteriorating steel pipe along the WS slope. The PVC pipe was attached to the steel pipe with duct tape and held together with metal zip ties. [Additional Reference(s): DWR Levee Log, 1991. USACE Sacramento O&M Manual Unit 111, May 1959 (River Mile 40.34)].  
FS Date: 8/24/2018

Gate valve missing handle.

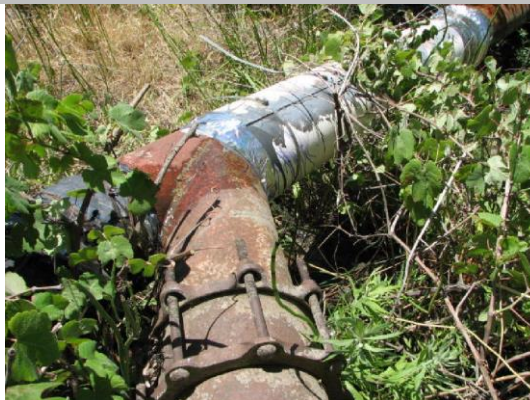
Photo 3 of 3 : UCIP\_FA\_2019\_53477\_20807.jpg

UCIP Comments: 08/24/2018 Everything appears to be the same as before. The intake pipe on the WS slope is in an unacceptable condition. A PVC pipe has been used to patch the deteriorating steel pipe, and it has been attached with duct tape. There are also metal zip ties along the PVC pipe section to hold it together. Tape was also used to cover another deteriorating section of the steel pipe. If the pipe is failing on the WS slope, then it's probably failing underneath the levee surface as well. Crossing remains "Urgent" due to the pipe integrity issues listed above. (A. McDonald - DWR UCIP)12/02/2016 Assumed same condition as last inspection--unable to verify damage reported during last inspection due to limited access to both WS and LS (steep slopes--safety issue). Crossing remains "Urgent" due to signs of sink hole/burrow activity visible along WS pipe alignment. Need to contact owner. Recommend internal integrity inspection be performed at this crossing to determine condition of pipe through the levee. (O. Magana - DWR UCIP)06/25/2012 2-foot deep 5-foot diameter sink hole over pipe at LS shoulder. Pipe has multiple repairs and leaks along water side slope. gate valve is in-operative. Pipe is likely failing internally. (W. Wylie - DWR UCIP)

FIELD\_STRUCT\_DESC: 12-inch steel irrigation pipe through levee, 17 feet below crown. Pump and gate valve on concrete stand box are located on the landside (LS) toe. Slant pump and 10-inch pipe sleeved into 12-inch pipe located on the waterside (WS) slope. A section of PVC pipe was used to patch the deteriorating steel pipe along the WS slope. The PVC pipe was attached to the steel pipe with duct tape and held together with metal zip ties. [Additional Reference(s): DWR Levee Log, 1991. USACE Sacramento O&M Manual Unit 111, May 1959 (River Mile 40.34)].

Pipe holes and patch job typical of large sections of pipe.

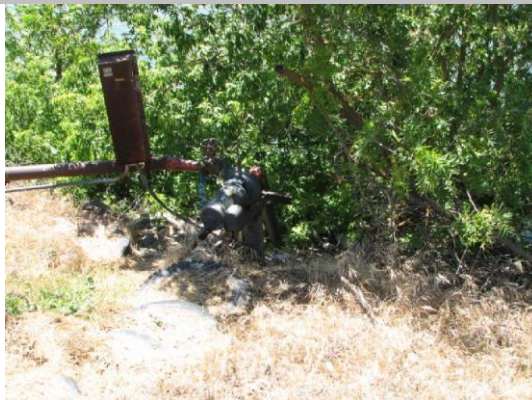
Photo 1 of 2 : UCIP\_FA\_2019\_41066\_7015.jpg

LM Start	15.80	Rating **	M	Issue No.	1833	
LM End	15.80	Issue Type +	En	Location *		
Category	Supplemental			GPS Latitude/Longitude		
				Start	End	
Item	DRAFT DWR UCIP Field Study			38.389530 °	38.389530 °	
				-121.512800 °	-121.512800 °	
DWR ID	17432					
Comment Code						
Inspector Comment						
DS_ID:17432 FS_ID:41066 EP_NO: N/A Repair Type: Non-Urgent Crossing Status: Indicator Found UCIP Comments: Pipe abandoned/grouted in place by DWR. Pipe not found but pump and appurtances good indicator of previous location. FIELD_STRUCT_DESC: *ABANDONED* 1 of 2: 8-inch abandoned pipe through levee, 12.7 feet below crown. Pressure grouted 8/68 by DWR. Originally included in O+M manual (1955). FS Date: 6/25/2012 1:39:00 PM

Pump at location where this pipe would have originally been located.

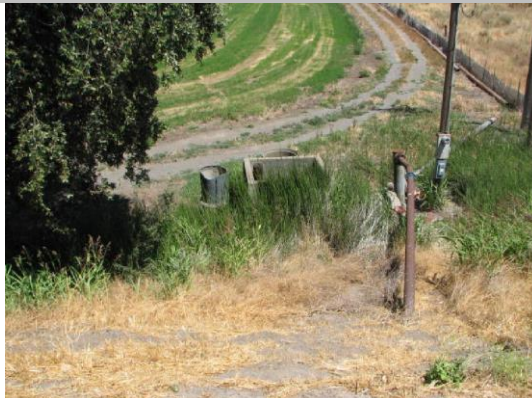
Photo 2 of 2 : UCIP\_FA\_2019\_41066\_7014.jpg

Concrete box and galvanized steel standpipe good indicator as to original pipe location.

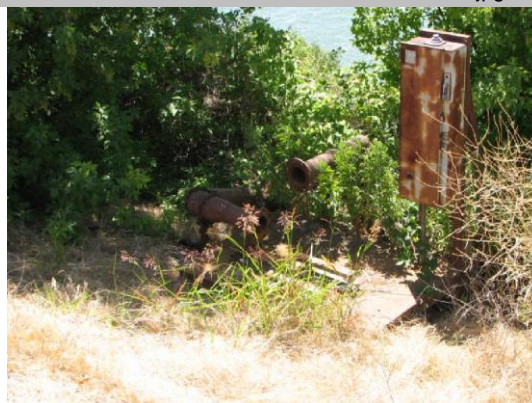
Photo 1 of 3 : UCIP\_FA\_2019\_53478\_20814.jpg

Comment Code					
Inspector Comment					
DS_ID:17433 FS_ID:53478 EP_NO: N/A Repair Type: Non-Urgent Crossing Status: Found UCIP Comments: 08/24/2018 Electrical panel and pipe sections still remain on the WS slope. Concrete box standpipe/distribution box remains at the LS toe, as well as a utility pole with an electrical panel on it. Crossing downgraded to "Non-Urgent" because no integrity issues were observed. (A. McDonald - DWR UCIP)12/02/2016 same as last inspection pipe has been abandoned. Crossing remains "Urgent" due to WS pipe inlet opened (unable to confirm--pipe has been disconnected). (O. Magana - DWR UCIP)06/25/2012 Pump and gate valve removed from pumphouse. Pipe needs to be closed or properly abandoned. (W. Wylie - DWR UCIP) FIELD_STRUCT_DESC: *ABANDONED* 8-inch steel irrigation pipe through levee, 13.3 feet below crown. Pump and gate valve missing from the waterside (WS) slope. Service pole and concrete distribution box located at the toe of landside (LS) slope. 1-inch galvanized steel electrical conduit through the levee parallel to the 8-inch pipe. [Additional Reference(s): DWR Levee Log, 1991. USACE Sacramento O&M Manual Unit 111, May 1959 (River Mile 39.99). FS Date: 8/24/2018

WS shoulder: pumphouse missing walls, pump, and gate valve

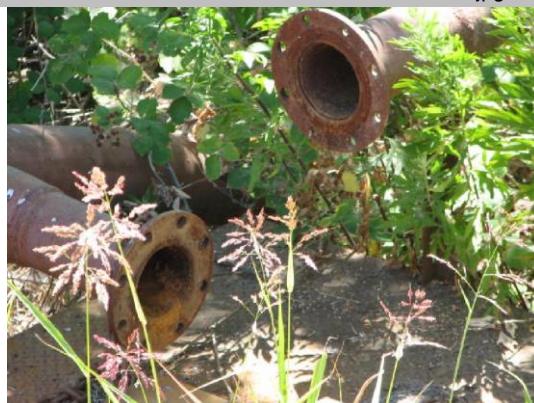
Photo 2 of 3 : UCIP\_FA\_2019\_53478\_20813.jpg

Item	DRAFT DWR UCIP Field Study			38.388480 °	38.388480 °	
				-121.513160 °	-121.513160 °	
DWR ID	17433					
Comment Code						
Inspector Comment						
DS_ID:17433 FS_ID:53478 EP_NO: N/A Repair Type: Non-Urgent Crossing Status: Found UCIP Comments: 08/24/2018 Electrical panel and pipe sections still remain on the WS slope. Concrete box standpipe/distribution box remains at the LS toe, as well as a utility pole with an electrical panel on it. Crossing downgraded to "Non-Urgent" because no integrity issues were observed. (A. McDonald - DWR UCIP)12/02/2016 same as last inspection pipe has been abandoned. Crossing remains "Urgent" due to WS pipe inlet opened (unable to confirm--pipe has been disconnected). (O. Magana - DWR UCIP)06/25/2012 Pump and gate valve removed from pumphouse. Pipe needs to be closed or properly abandoned. (W. Wylie - DWR UCIP) FIELD_STRUCT_DESC: *ABANDONED* 8-inch steel irrigation pipe through levee, 13.3 feet below crown. Pump and gate valve missing from the waterside (WS) slope. Service pole and concrete distribution box located at the toe of landside (LS) slope. 1-inch galvanized steel electrical conduit through the levee parallel to the 8-inch pipe. [Additional Reference(s): DWR Levee Log, 1991. USACE Sacramento O&M Manual Unit 111, May 1959 (River Mile 39.99). FS Date: 8/24/2018

Open pipe where pump and gate valve should be located.

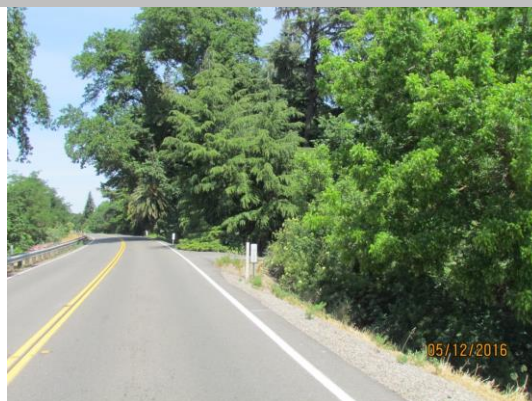
Photo 1 of 1 : FA\_2019\_MA0009\_201\_202\_20190904\_00129.jpg

LM Start	16.04	Rating **	M	Issue No.	202
LM End	16.12	Issue Type +	En	Location *	LS
Category	Earthen Levee			GPS Latitude/Longitude	
				Start	End
Item	Vegetation			38.386248 °	38.385235 °
				-121.514202 °	-121.515025 °
DWR ID	DWR_MA0009_01_s_2012_202				
Comment Code					
V6 : Landscaping					
Inspector Comment					
Trees over levee slope need to be trimmed.

View of the trees on the landward slope of the levee looking upstream.  
Spring 2016.

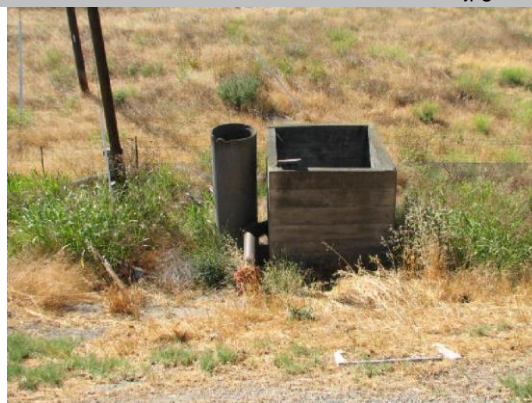
Photo 1 of 3 : UCIP\_FA\_2019\_5186\_7023.jpg

LM Start	16.15	Rating **	M	Issue No.	1835
LM End	16.15	Issue Type +	En	Location *	
Category	Supplemental			GPS Latitude/Longitude	
				Start	End
Item	DRAFT DWR UCIP Field Study			38.384990 °	38.384990 °
				-121.515280 °	-121.515280 °
DWR ID	17434				
Comment Code					
Inspector Comment					
DS_ID:17434					
FS_ID:5186					
EP_NO: N/A					
Repair Type: Non-Urgent					
Crossing Status: Found					
UCIP Comments: Pump missing from platform.					
FIELD_STRUCT_DESC: 8-inch pipe through levee, 11.8 feet below crown. Slant pump on waterward slope. gate valve, 24-inch concrete standpipe, and concrete distribution box on LS toe. Meter on pole LS toe. 1-inch galvanized steel electrical conduit through the levee 11.8 feet below the crown. Originally included in O+M manual (1955).					
FS Date: 6/26/2012 2:02:36 PM

Gate valve, standpipe, concret distribution box, pole, and meter on LS toe.

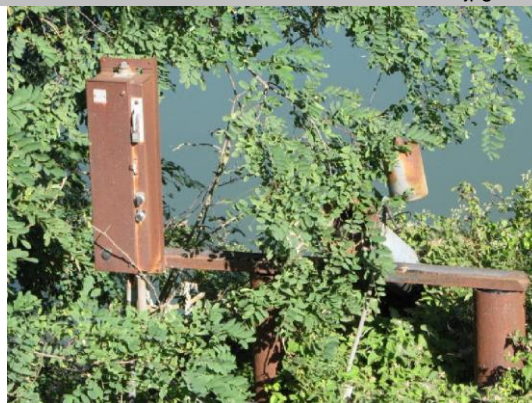
Photo 2 of 3 : UCIP\_FA\_2019\_5186\_7022.jpg

Open pump house with breaker and missing pump shown.

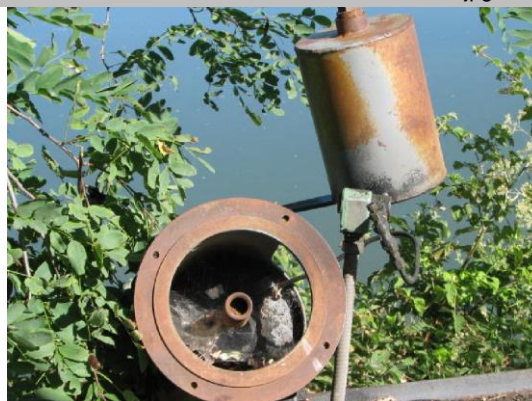
Photo 3 of 3 : UCIP\_FA\_2019\_5186\_7021.jpg

LM Start	16.15	Rating **	M	Issue No.	1835 (cont)	
LM End	16.15	Issue Type +	En	Location *		
Category	Supplemental			GPS Latitude/Longitude		
				Start	End	
Item	DRAFT DWR UCIP Field Study			38.384990 °	38.384990 °	
				-121.515280 °	-121.515280 °	
DWR ID	17434					
Comment Code						
Inspector Comment						
DS_ID:17434 FS_ID:5186 EP_NO: N/A Repair Type: Non-Urgent Crossing Status: Found UCIP Comments: Pump missing from platform. FIELD_STRUCT_DESC: 8-inch pipe through levee, 11.8 feet below crown. Slant pump on waterward slope. gate valve, 24-inch concrete standpipe, and concrete distribution box on LS toe. Meter on pole LS toe. 1-inch galvanized steel electrical conduit through the levee 11.8 feet below the crown. Originally included in O+M manual (1955). FS Date: 6/26/2012 2:02:36 PM

Missing pump.

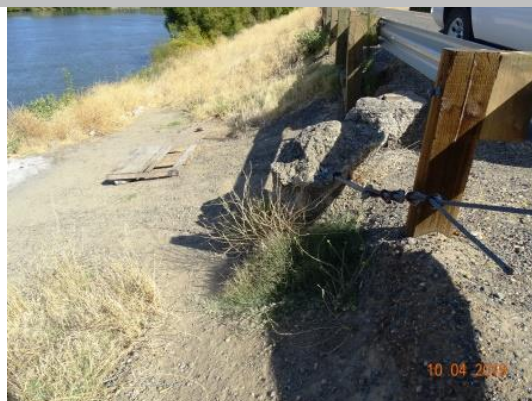
Photo 1 of 3 : FA\_2019\_MA0009\_201\_433\_20191010\_00546.jpg

LM Start	16.80	Rating **	U	Issue No.	433
LM End	16.80	Issue Type +	Ma	Location *	WS
Category	Earthen Levee			GPS Latitude/Longitude	
				Start	End
Item	Erosion / Bank Caving			38.378335 °	38.378335 °
				-121.523509 °	-121.523509 °
DWR ID	DWR_MA0009_01_f_2017_433				
Comment Code					
E2 : Schedule repair of erosion site prior to the next inspection.					
Inspector Comment					
Erosion worsened, as guardrails needed to be anchored to other posts.

View of erosion and anchored guardrail posts. Fall 2019

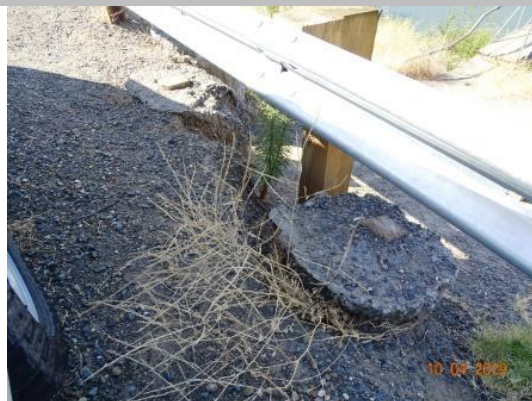
Photo 2 of 3 : FA\_2019\_MA0009\_201\_433\_20191010\_00547.jpg

View of erosion at waterside hinge point. Fall 2019

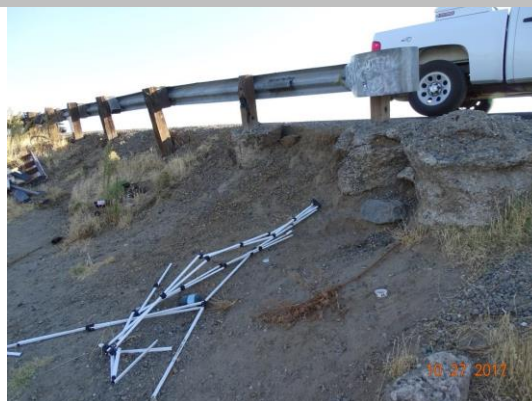
Photo 3 of 3 : FA\_2019\_MA0009\_201\_433\_20190904\_00283.jpg

LM Start	16.80	Rating **	U	Issue No.	433 (cont)	
LM End	16.80	Issue Type +	Ma	Location *	WS	
Category	Earthen Levee			GPS Latitude/Longitude		
				Start		End
Item	Erosion / Bank Caving			38.378335 °		38.378335 °
				-121.523509 °		-121.523509 °
DWR ID	DWR_MA0009_01_f_2017_433					
Comment Code						
E2 : Schedule repair of erosion site prior to the next inspection.						
Inspector Comment						
Erosion worsened, as guardrails needed to be anchored to other posts.

View of erosion at hinge point. Fall 2017.

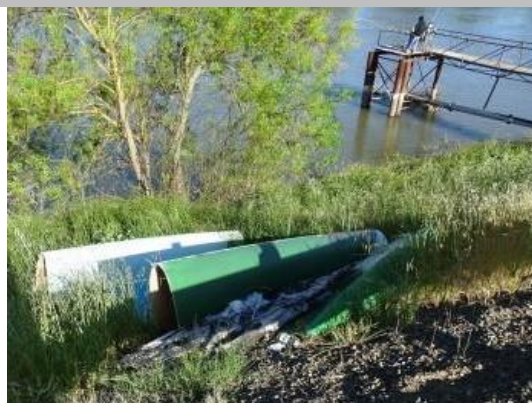
Photo 1 of 1 : FA\_2019\_MA0009\_201\_463\_20190904\_00285.jpg

LM Start	16.82	Rating **	M	Issue No.	463
LM End	16.82	Issue Type +	Ma	Location *	WS
Category	Earthen Levee			GPS Latitude/Longitude	
				Start	End
Item	Encroachments			38.378047 °	38.378047 °
				-121.523585 °	-121.523585 °
DWR ID	DWR_MA0009_01_s_2019_463				
Comment Code					
DE : Debris					
Inspector Comment					
Remove debris from levee slope.

View of debris on waterside slope. Spring 2019

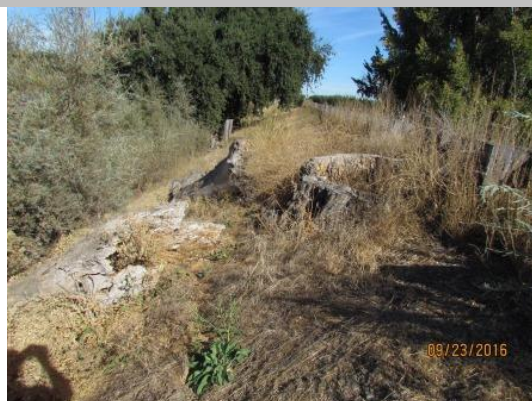
Photo 1 of 1 : FA\_2019\_MA0009\_201\_258\_20190904\_00181.jpg

LM Start	17.18	Rating **	N	Issue No.	258
LM End	17.18	Issue Type +	Ma	Location *	WS
Category	Earthen Levee			GPS Latitude/Longitude	
				Start	End
Item	Trim / Thin Trees			38.373060°	38.373060°
				-121.521868°	-121.521868°
DWR ID	DWR_MA0009_01_f_2016_258				
Comment Code					
T5 : Tree stumps.					
Inspector Comment

Decomposing tree body and root on waterside slope looking upstream.  
Fall 2016.

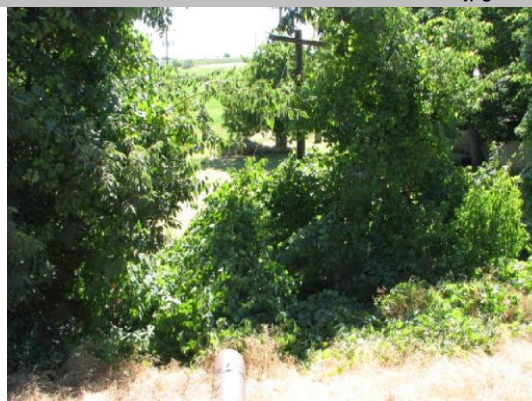
Photo 1 of 3 : UCIP\_FA\_2019\_5222\_7111.jpg

LM Start	17.36	Rating **	M	Issue No.	1839
LM End	17.36	Issue Type +	En	Location *	
Category	Supplemental			GPS Latitude/Longitude	
				Start	End
Item	DRAFT DWR UCIP Field Study			38.370596 °	38.370596 °
				-121.520907 °	-121.520907 °
DWR ID	17452				
Comment Code					
Inspector Comment					
DS_ID:17452 FS_ID:5222 EP_NO: N/A Repair Type: Non-Urgent Crossing Status: Found UCIP Comments: Pump disconnected from pipe in pumphouse. FIELD_STRUCT_DESC: 8-inch steel pipe sleeved through 10-inch pipe on WS and 10-inch pipe sleeved through 12-inch pipe on LS, 6.0 feet below crown. Pump disconnected and gate valve in pump house on waterward slope. 1.5-inch steel electrical conduit through the levee and parallel to the 8-inch steel pipe. Originally included in O+M manual (1955). FS Date: 6/26/2012 3:02:29 PM

Concrete standpipe under heavy vegetation at LS toe.

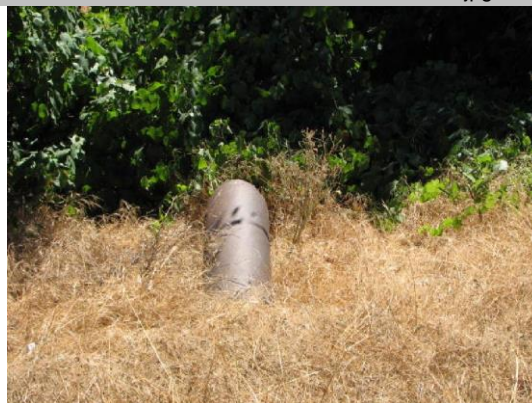
Photo 2 of 3 : UCIP\_FA\_2019\_5222\_7110.jpg

10-inch sleeved through a 12-inch pipe on the LS shoulder.

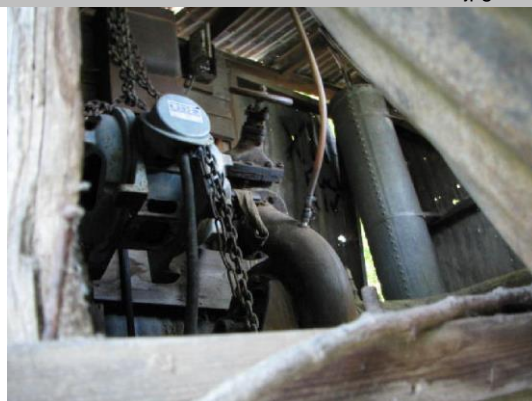
Photo 3 of 3 : UCIP\_FA\_2019\_5222\_7109.jpg

LM Start	17.36	Rating **	M	Issue No.	1839 (cont)	
LM End	17.36	Issue Type +	En	Location *		
Category	Supplemental			GPS Latitude/Longitude		
				Start	End	
Item	DRAFT DWR UCIP Field Study			38.370596 °	38.370596 °	
				-121.520907 °	-121.520907 °	
DWR ID	17452					
Comment Code						
Inspector Comment						
DS_ID:17452 FS_ID:5222 EP_NO: N/A Repair Type: Non-Urgent Crossing Status: Found UCIP Comments: Pump disconnected from pipe in pumphouse. FIELD_STRUCT_DESC: 8-inch steel pipe sleeved through 10-inch pipe on WS and 10-inch pipe sleeved through 12-inch pipe on LS, 6.0 feet below crown. Pump disconnected and gate valve in pump house on waterward slope. 1.5-inch steel electrical conduit through the levee and parallel to the 8-inch steel pipe. Originally included in O+M manual (1955). FS Date: 6/26/2012 3:02:29 PM

Pump removed from pipe inside pumphouse on WS.

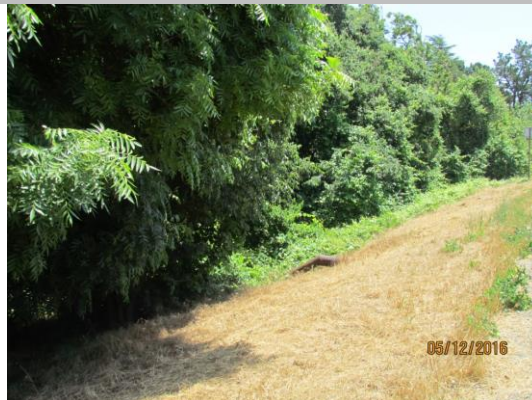
Photo 1 of 1 : FA\_2019\_MA0009\_201\_199\_20190904\_00125.jpg

LM Start	17.37	Rating **	M	Issue No.	199
LM End	17.37	Issue Type +	En	Location *	LS
Category	Earthen Levee			GPS Latitude/Longitude	
				Start	End
Item	Vegetation			38.370453°	38.370453°
				-121.520878°	-121.520878°
DWR ID	DWR_MA0009_01_s_2017_199				
Comment Code					
V6 : Landscaping					
Inspector Comment

View of the trees and shrubs on the landward side of the levee looking downstream. Spring 2016.

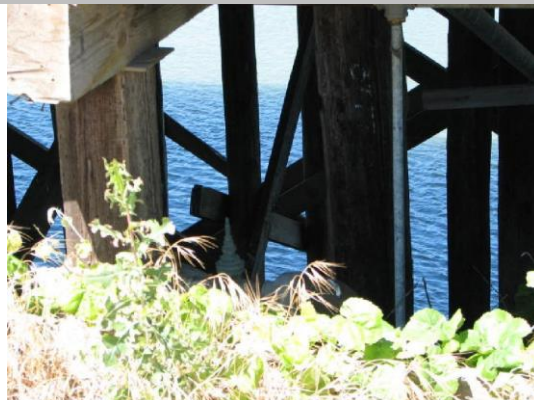
Photo 2 of 3 : UCIP\_FA\_2019\_5933\_9042.jpg

LM Start	17.49	Rating **	M	Issue No.	1841 (cont)
LM End	17.49	Issue Type +	En	Location *	
Category	Supplemental			GPS Latitude/Longitude	
				Start	End
Item	DRAFT DWR UCIP Field Study			38.368740 °	38.368740 °
				-121.520400 °	-121.520400 °
DWR ID	18964				
Comment Code					
Inspector Comment					
DS_ID:18964 FS_ID:5933 EP_NO: N/A Repair Type: Non-Urgent Crossing Status: Found UCIP Comments: No permit identified for this crossing. FIELD_STRUCT_DESC: 4-inch steel water line through the levee, 3.5 feet below the crown. Shutoff valve on the waterside (WS) slope under building. FS Date: 6/26/2012 4:02:26 PM

Valve sticking up under building on WS slope.

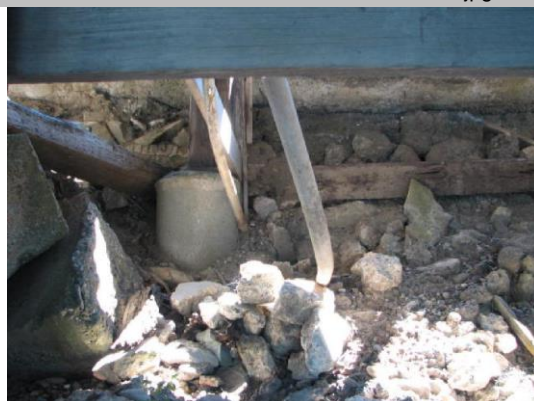
Photo 1 of 2 : UCIP\_FA\_2019\_5934\_9045.jpg

LM Start	17.50	Rating **	M	Issue No.	1842
LM End	17.50	Issue Type +	En	Location *	
Category	Supplemental			GPS Latitude/Longitude	
				Start	End
Item	DRAFT DWR UCIP Field Study			38.368590°	38.368590°
				-121.520310°	-121.520310°
DWR ID	18965				
Comment Code					
Inspector Comment					
DS_ID:18965 FS_ID:5934 EP_NO: N/A Repair Type: Non-Urgent Crossing Status: Found UCIP Comments: No permit identified for this crossing. FIELD_STRUCT_DESC: 2.5-inch steel electrical conduit through the levee, 6 feet below the crown. Pipe visible under building on the waterside (WS) slope. FS Date: 6/26/2012 4:04:34 PM

Pipes through levee on WS slope.

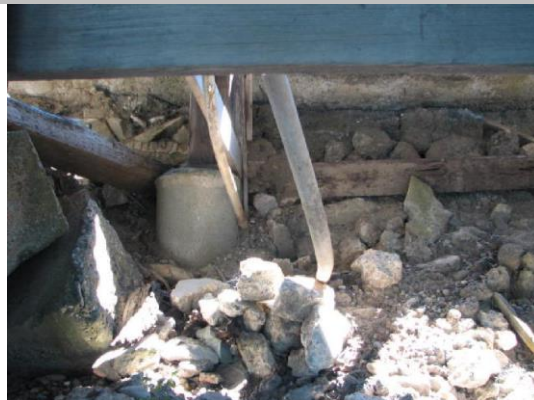
Photo 1 of 2 : UCIP\_FA\_2019\_5935\_9047.jpg

LM Start	17.50	Rating **	M	Issue No.	1843
LM End	17.50	Issue Type +	En	Location *	
Category	Supplemental			GPS Latitude/Longitude	
				Start	End
Item	DRAFT DWR UCIP Field Study			38.368580 °	38.368580 °
				-121.520310 °	-121.520310 °
DWR ID	18966				
Comment Code					
Inspector Comment					
DS_ID:18966					
FS_ID:5935					
EP_NO: N/A					
Repair Type: Non-Urgent					
Crossing Status: Found					
UCIP Comments: No permit identified for this crossing.					
FIELD_STRUCT_DESC: 2-inch steel electrical conduit through the					
levee, 7 feet below the crown. Pipe visible under building on the					
waterside (WS) slope.					
FS Date: 6/26/2012 4:06:28 PM

Pipes through levee on WS slope.

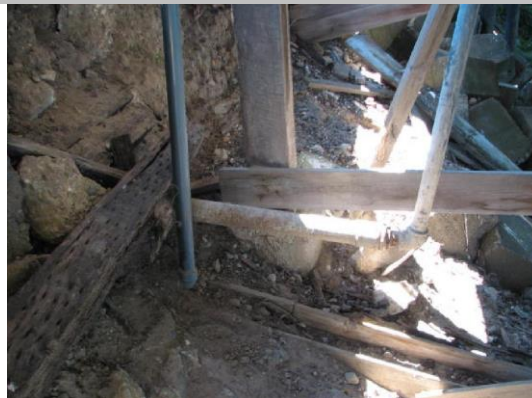
Photo 1 of 1 : UCIP\_FA\_2019\_5936\_9048.jpg

LM Start	17.50	Rating **	M	Issue No.	1844
LM End	17.50	Issue Type +	En	Location *	
Category	Supplemental			GPS Latitude/Longitude	
				Start	End
Item	DRAFT DWR UCIP Field Study			38.368570 °	38.368570 °
				-121.520310 °	-121.520310 °
DWR ID	18968				
Comment Code					
Inspector Comment					
DS_ID:18968					
FS_ID:5936					
EP_NO: N/A					
Repair Type: Non-Urgent					
Crossing Status: Found					
UCIP Comments: No permits identified for this crossing.					
FIELD_STRUCT_DESC: 2-inch polyvinyl chloride (PVC) pipe of an unknown purpose through the levee, 5.5 feet below the crown. Pipe visible under building on the waterside (WS) slope.					
FS Date: 6/26/2012 4:07:33 PM

Pipes through levee on WS slope.

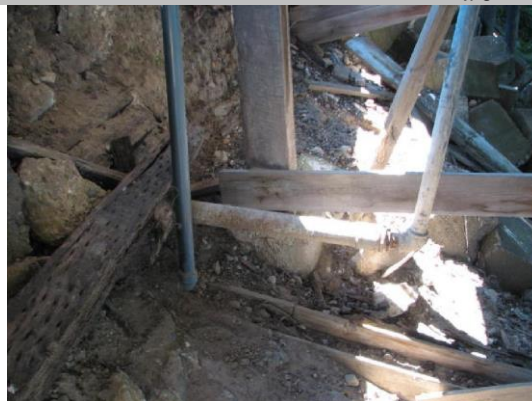
Photo 1 of 2 : UCIP\_FA\_2019\_5937\_9050.jpg

LM Start	17.50	Rating **	M	Issue No.	1845
LM End	17.50	Issue Type +	En	Location *	
Category	Supplemental			GPS Latitude/Longitude	
				Start	End
Item	DRAFT DWR UCIP Field Study			38.368560 °	38.368560 °
				-121.520300 °	-121.520300 °
DWR ID	18967				
Comment Code					
Inspector Comment					
DS_ID:18967					
FS_ID:5937					
EP_NO: N/A					
Repair Type: Non-Urgent					
Crossing Status: Found					
UCIP Comments: No permit identified for this crossing.					
FIELD_STRUCT_DESC: 4-inch steel water line through the levee, 5 feet below the crown. Pipe visible under building on the waterside (WS) slope.					
FS Date: 6/26/2012 4:08:42 PM

Pipes through levee on WS slope.

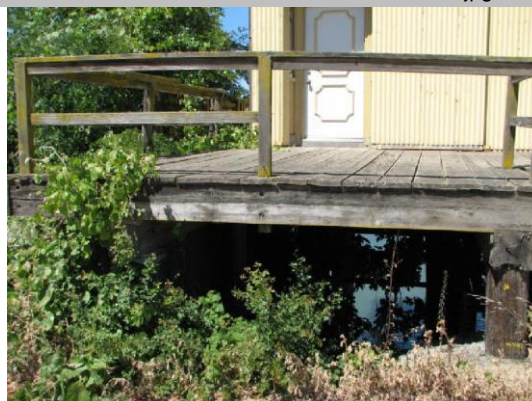
Photo 2 of 2 : UCIP\_FA\_2019\_5938\_9051.jpg

LM Start	17.52	Rating **	M	Issue No.	1846 (cont)	
LM End	17.52	Issue Type +	En	Location *		
Category	Supplemental			GPS Latitude/Longitude		
				Start	End	
Item	DRAFT DWR UCIP Field Study			38.368270 °	38.368270 °	
				-121.520220 °	-121.520220 °	
DWR ID	18969					
Comment Code						
Inspector Comment						
DS_ID:18969						
FS_ID:5938						
EP_NO: N/A						
Repair Type: Non-Urgent						
Crossing Status: Found						
UCIP Comments: No permit identified for this crossing.						
FIELD_STRUCT_DESC: 4-inch cast iron sewer line through the levee, 2.5 feet below the crown. Pipe visible under building on the waterside (WS) slope.						
FS Date: 6/26/2012 4:10:08 PM

Pipe under south corner of building on WS slope.

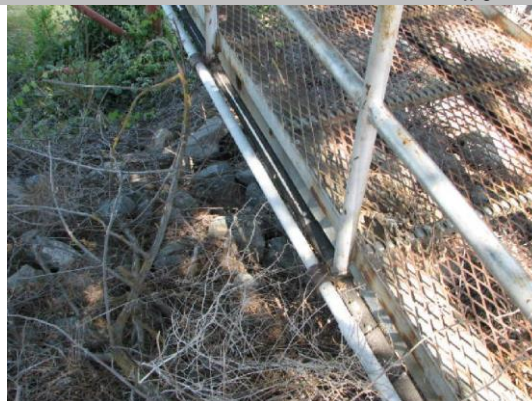
Photo 1 of 2 : UCIP\_FA\_2019\_5939\_9054.jpg

LM Start	17.57	Rating **	M	Issue No.	1847	
LM End	17.57	Issue Type +	En	Location *		
Category	Supplemental			GPS Latitude/Longitude		
				Start	End	
Item	DRAFT DWR UCIP Field Study			38.367650 °	38.367650 °	
				-121.520040 °	-121.520040 °	
DWR ID	18963					
Comment Code						
Inspector Comment						
DS_ID:18963 FS_ID:5939 EP_NO: N/A Repair Type: Non-Urgent Crossing Status: Found UCIP Comments: No permit identified for this crossing. FIELD_STRUCT_DESC: 1-inch polyvinyl chloride (PVC) domestic water line through the levee, 1.5 feet below the crown. Pipe runs from corner of building to pump house catwalk on the waterside (WS) shoulder. FS Date: 7/25/2012 4:11:55 PM

PVC waterline on downstream side of pier walkway.

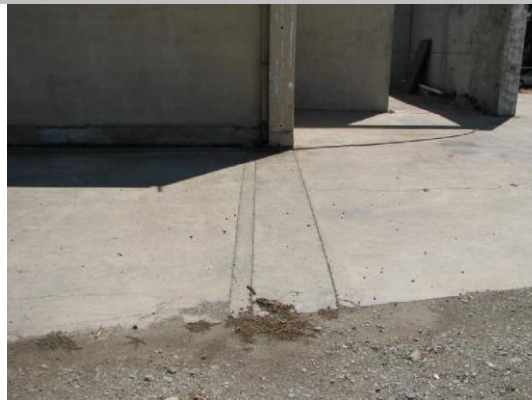
Photo 2 of 2 : UCIP\_FA\_2019\_5939\_9053.jpg

LM Start	17.57	Rating **	M	Issue No.	1847 (cont)	
LM End	17.57	Issue Type +	En	Location *		
Category	Supplemental			GPS Latitude/Longitude		
				Start	End	
Item	DRAFT DWR UCIP Field Study			38.367650 °	38.367650 °	
				-121.520040 °	-121.520040 °	
DWR ID	18963					
Comment Code						
Inspector Comment						
DS_ID:18963 FS_ID:5939 EP_NO: N/A Repair Type: Non-Urgent Crossing Status: Found UCIP Comments: No permit identified for this crossing. FIELD_STRUCT_DESC: 1-inch polyvinyl chloride (PVC) domestic water line through the levee, 1.5 feet below the crown. Pipe runs from corner of building to pump house catwalk on the waterside (WS) shoulder. FS Date: 7/25/2012 4:11:55 PM

cut through concrete at building on LS shoulder where waterline was installed (per inspector).

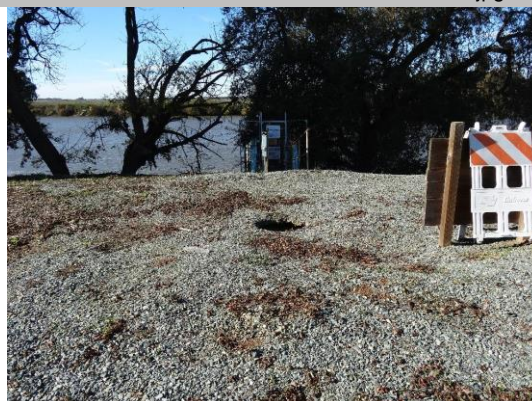
Photo 2 of 3 : UCIP\_FA\_2019\_53479\_76372.jpg

WS view: Sink hole present along pipe alignment.

Comment Code
Inspector Comment
<p>DS_ID:17682  FS_ID:53479  EP_NO: 9635  Repair Type: Urgent  Crossing Status: Found  UCIP Comments: 08/24/2018 Sink hole has been excavated. It does not appear that anything else has been done besides that. No additional documentation has been provided by the owner, the LMA, or CVFPB. As they discussed with Clay Booher of DWR, the CVFPB determined that it would be best to not remove all sections of the pipe. Instead they suggest to remove the exposed section of the pipe and recompacting the soil. Clay Booher will update the plans and send in a repair plan in September. Crossing remains "Urgent" until further action is taken to abandon it properly. (A. McDonald - DWR UCIP)12/02/2016 Sink hole has developed in the last few weeks according to LMA representative. Hole through pipe section was also observed during inspection. Need to contact owner to inform owner of pipe failure and to stop use of crossing to avoid further damage to levee. (O. Magana - DWR UCIP)06/26/2012 No apparent closure device on pipe and pipe has no indication that it was properly abandoned. Urgent do to size of pipe. (W. Wylie - DWR UCIP)  FIELD_STRUCT_DESC: 3 of 3: 36-inch corrugated metal drainage pipe through the levee, 5 feet below the crown. Pipe runs under the pier walkway from the location of a removed fish screen test facility at the centerline of the levee back to the river. A 4-inch steel conduit runs parallel to the 36-inch pipe and terminates in the 36-inch pipe near the waterside (WS) slope. A sink hole has developed, November 2016. (Fish screen clogging engineering test facility with pump authorized under Permit Nos. 9635, 1974, and 9635-B, 1975 - State of California, Department of Water Resources [DWR], Central District, Delta Branch. Permit No. 9635-A, 1975 - State of California, Department of Water Resources [DWR], Central District, Delta Branch, issued for two trailers on the crown and the installation of a septic system. Facility is temporary. It should have been removed on July 1, 1977, per permit recordation, Page 29 or 76).  FS Date: 8/24/2018</p>

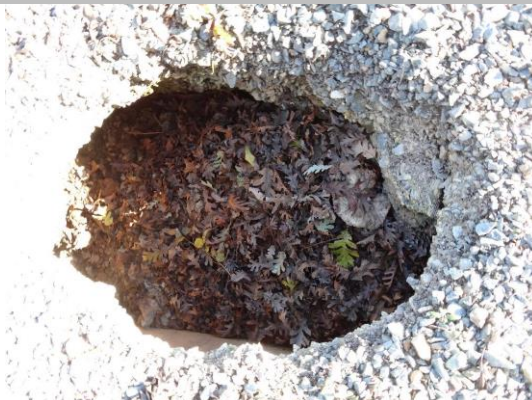
Photo 3 of 3 : UCIP\_FA\_2019\_53479\_76373.jpg

UCIP Comments: 08/24/2018 Sink hole has been excavated. It does not appear that anything else has been done besides that. No additional documentation has been provided by the owner, the LMA, or CVFPB. As they discussed with Clay Booher of DWR, the CVFPB determined that it would be best to not remove all sections of the pipe. Instead they suggest to remove the exposed section of the pipe and recompact the soil. Clay Booher will update the plans and send in a repair plan in September. Crossing remains "Urgent" until further action is taken to abandon it properly. (A. McDonald - DWR UCIP)12/02/2016 Sink hole has developed in the last few weeks according to LMA representative. Hole through pipe section was also observed during inspection. Need to contact owner to inform owner of pipe failure and to stop use of crossing to avoid further damage to levee. (O. Magana - DWR UCIP)06/26/2012 No apparent closure device on pipe and pipe has no indication that it was properly abandoned. Urgent do to size of pipe. (W. Wylie - DWR UCIP)

WS view: 2.5-feet by 3-feet sink hole present on WS.

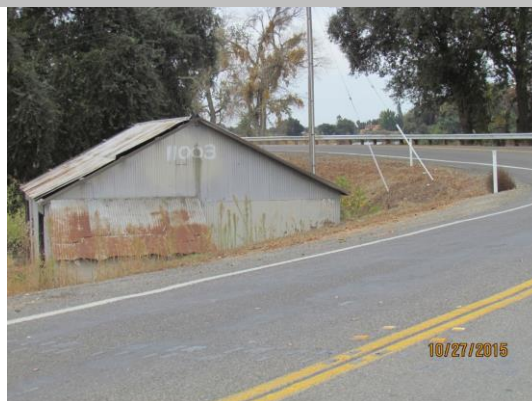
Photo 1 of 1 : FA\_2019\_MA0009\_201\_198\_20190904\_00124.jpg

LM Start	17.62	Rating **	M	Issue No.	198
LM End	17.62	Issue Type +	En	Location *	LS
Category	Earthen Levee			GPS Latitude/Longitude	
				Start	End
Item	Encroachments			38.366900 °	38.366900 °
				-121.520022 °	-121.520022 °
DWR ID	DWR_MA0009_01_s_2012_198				
Comment Code					
BU : Building					
Inspector Comment					
Pumphouse downstream of the Town of Hood.

View of the old pumphouse at the toe of the levee on the landward side looking downstream. Fall 2015.

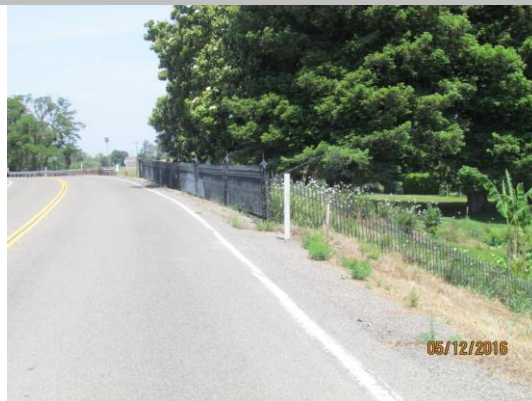
Photo 1 of 1 : FA\_2019\_MA0009\_201\_40\_20190904\_00015.jpg

LM Start	18.08	Rating **	M	Issue No.	40
LM End	18.08	Issue Type +	En	Location *	LS
Category	Earthen Levee			GPS Latitude/Longitude	
				Start	End
Item	Encroachments			38.360380 °	38.360380 °
				-121.520776 °	-121.520776 °
DWR ID	DWR_MA0009_01_s_2016_40				
Comment Code					
FE : Fence					
Inspector Comment					
The wrought iron fence does not appear to be authorized.

View of the wrought iron fence on the shoulder of the levee on the landward side looking upstream. Spring 2016.

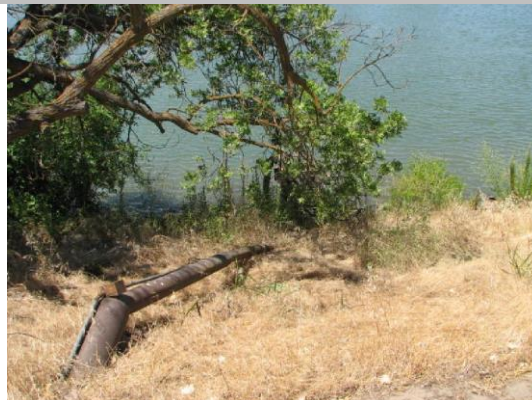
Photo 1 of 3 : UCIP\_FA\_2019\_41064\_7277.jpg

12-inch with 8-inch on WS slope and 1.25-inch electrical conduit.

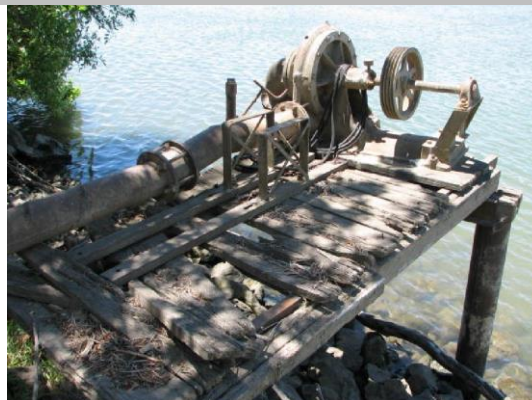
Photo 2 of 3 : UCIP\_FA\_2019\_41064\_7276.jpg

Pump on Pier on WS toe.

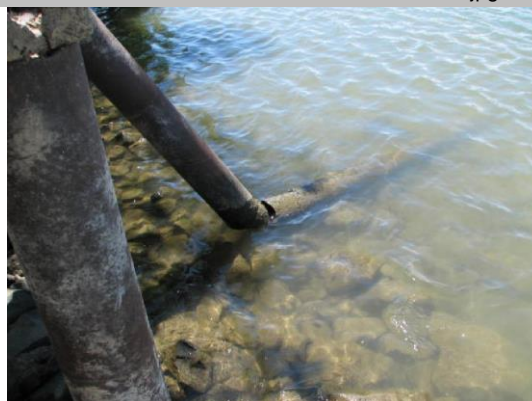
Photo 3 of 3 : UCIP\_FA\_2019\_41064\_7275.jpg

Item	DRAFT DWR UCIP Field Study			38.360178 °		38.360178 °
				-121.521098 °		-121.521098 °
DWR ID	17688					
Comment Code						
Inspector Comment						
DS_ID:17688 FS_ID:41064 EP_NO: 2391 Repair Type: Non-Urgent Crossing Status: Found UCIP Comments: Pump and pipe appear to be abandoned. Need to properly abandon pipe and pump. Pier is a hazardous attractive nuisance. FIELD_STRUCT_DESC: 2 of 2: 12-inch pipe through levee, 7.3 feet below crown with an 8-inch pipe sleeved through it. Pipe and gate valve on waterward side attached to a pump on a pier. 1.25-inch galvanized steel electrical conduit through levee parallel to the 12-inch. 24-inch concrete standpipe, JP, and meter at LS toe (Permit No. 2391). Originally included in O+M manual (1955). FS Date: 6/26/2012 7:49:00 AM

Ruptured pipe in water at WS toe.

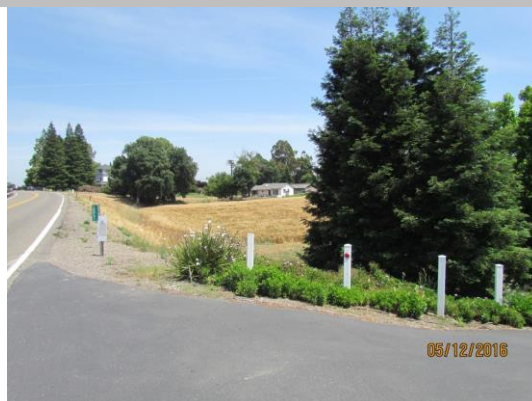
Photo 1 of 1 : FA\_2019\_MA0009\_201\_197\_20190904\_00123.jpg

LM Start	18.16	Rating **	M	Issue No.	197
LM End	18.16	Issue Type +	En	Location *	LS
Category	Earthen Levee			GPS Latitude/Longitude	
				Start	End
Item	Vegetation			38.359501°	38.359501°
				-121.521774°	-121.521774°
DWR ID	DWR_MA0009_01_s_2012_197				
Comment Code					
V6 : Landscaping					
Inspector Comment

View of the groundcover and redwood trees on the landward side of the levee looking upstream. Spring 2016.

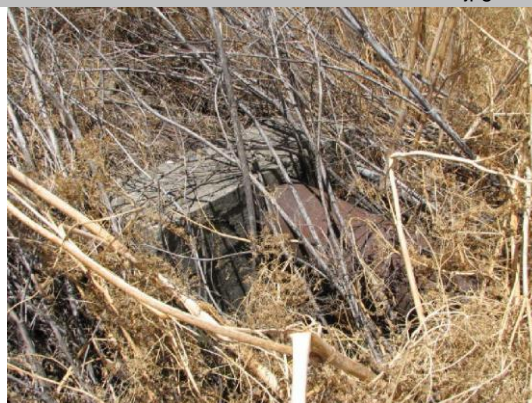
Photo 1 of 3 : UCIP\_FA\_2019\_5305\_7280.jpg

LM Start	18.22	Rating **	M	Issue No.	1850	
LM End	18.22	Issue Type +	En	Location *		
Category	Supplemental			GPS Latitude/Longitude		
				Start	End	
Item	DRAFT DWR UCIP Field Study			38.359050 °	38.359050 °	
				-121.522800 °	-121.522800 °	
DWR ID	17446					
Comment Code						
Inspector Comment						
DS_ID:17446						
FS_ID:5305						
EP_NO: N/A						
Repair Type: Non-Urgent						
Crossing Status: Found						
UCIP Comments: Could not verify welded steel plates on either end of pipe. Pipe needs to be properly abandoned.						
FIELD_STRUCT_DESC: *ABANDONED* 10-inch pipe through levee, 8.8 feet below crown. Steel plate welded on both ends by United States Army Corps of Engineers. Pipe visible on LS 5-feet upstream from 4X4 concrete box on LS toe. Originally included in O+M manual (1955).						
FS Date: 6/26/2012 8:06:32 AM

Pipe through concrete block on LS toe

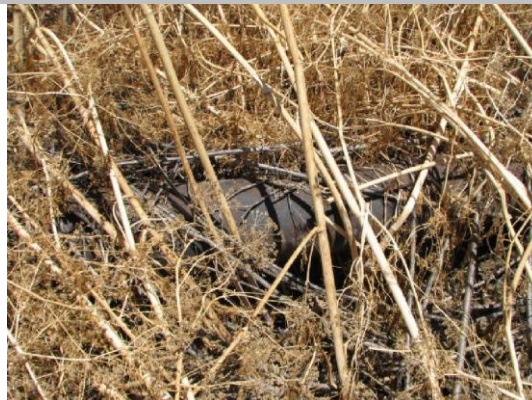
Photo 2 of 3 : UCIP\_FA\_2019\_5305\_7279.jpg

Pipe on LS toe.

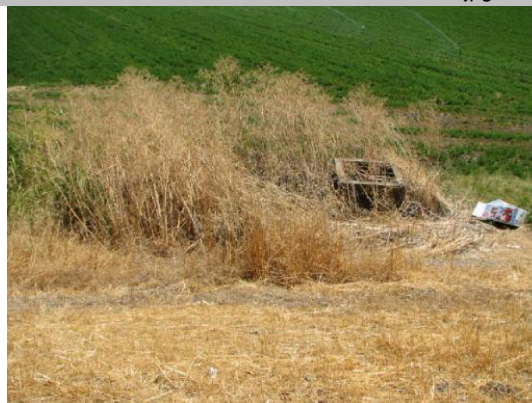
Photo 3 of 3 : UCIP\_FA\_2019\_5305\_7278.jpg

Pipe 5-feet upstream from 4X4 concrete box on LS toe.

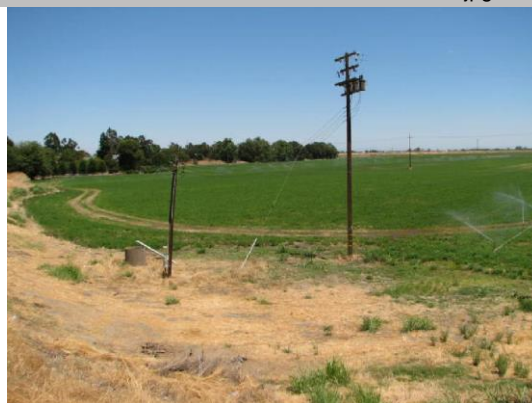
Photo 1 of 3 : UCIP\_FA\_2019\_5306\_7283.jpg

Comment Code					
Inspector Comment					
DS_ID:17447					
FS_ID:5306					
EP_NO: N/A					
Repair Type: Non-Urgent					
Crossing Status: Found					
UCIP Comments: Pump leaking oil and siphon breaker on landward slope is burried or has been removed. Need to repair oil leak, locate/repair siphon breaker, and remove foliage from around gate valve on WS.					
FIELD_STRUCT_DESC: 1 of 3: 10-inch pipe through levee, 7.0 feet below crown. Slant pump on pile structure in stream. Siphon break on landward slope buried. One cm cutoff wall. Service pole and concrete standpipe on landward side. Originally included in O+M manual (1955).					
FS Date: 6/26/2012 8:35:06 AM

Concrete standpipe, Joint pole, and meter on LS toe.

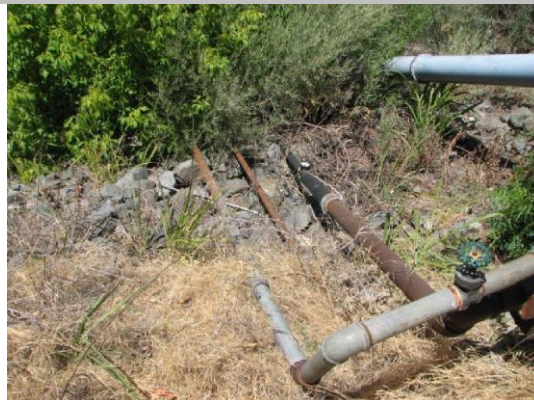
Photo 2 of 3 : UCIP\_FA\_2019\_5306\_7282.jpg

various pipes on WS slope that accompany the slant pump.

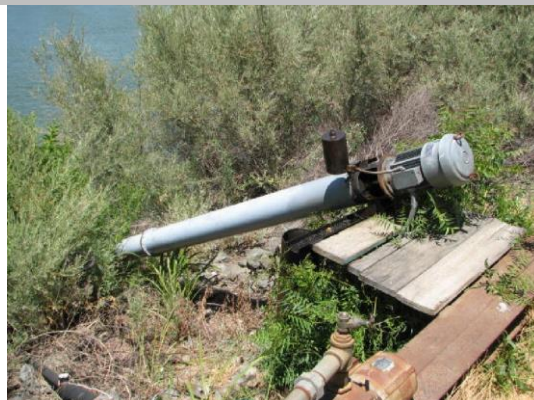
Photo 3 of 3 : UCIP\_FA\_2019\_5306\_7281.jpg

Slant pump on pile structure on WS slope.

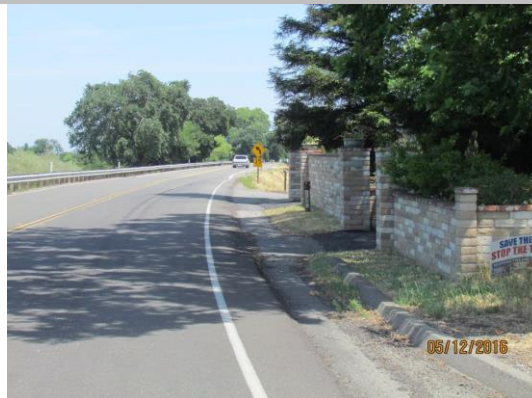
Photo 1 of 1 : FA\_2019\_MA0009\_201\_956\_20190904\_00304.jpg

LM Start	18.32	Rating **	M	Issue No.	956
LM End	18.32	Issue Type +	En	Location *	LS
Category	Earthen Levee			GPS Latitude/Longitude	
				Start	End
Item	Encroachments			38.358278 °	38.358278 °
				-121.524323 °	-121.524323 °
DWR ID	DWR_MA0009_01_s_2012_956				
Comment Code					
FE : Fence					
Inspector Comment					
The brick fence does not appear to be authorized.

View of the brick wall and landscaping on the landward side of the levee looking upstream. Spring 2016.

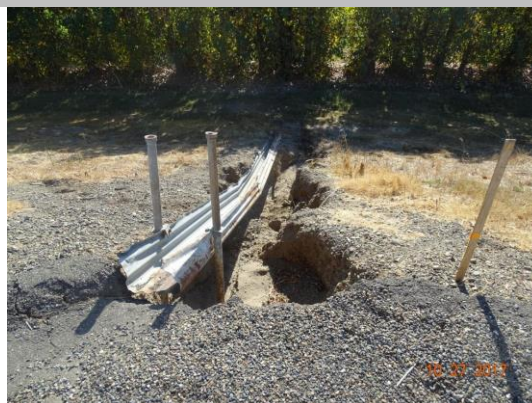
Photo 1 of 2 : FA\_2019\_MA0009\_201\_332\_20190904\_00232.jpg

LM Start	18.43	Rating **	U	Issue No.	332
LM End	18.43	Issue Type +	Ma	Location *	LS
Category	Earthen Levee			GPS Latitude/Longitude	
				Start	End
Item	Erosion / Bank Caving			38.357278 °	38.357278 °
				-121.525817 °	-121.525817 °
DWR ID	DWR_MA0009_01_s_2017_332				
Comment Code					
E2 : Schedule repair of erosion site prior to the next inspection.					
Inspector Comment					
Erosion on landside slope next to drainage gutter.

Updated view of erosion. Fall 2017.

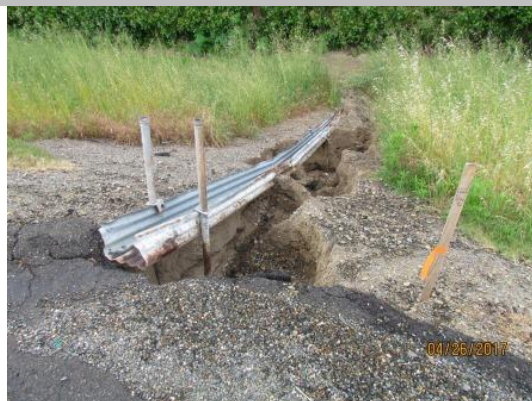
Photo 2 of 2 : FA\_2019\_MA0009\_201\_332\_20190904\_00233.jpg

View of erosion on landside levee slope. Spring 2017.

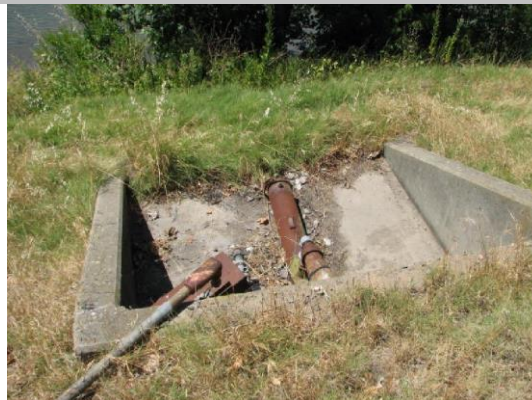
Photo 1 of 3 : UCIP\_FA\_2019\_5311\_7294.jpg

DS\_ID:17449  
FS\_ID:5311  
EP\_NO: N/A  
Repair Type: Non-Urgent  
Crossing Status: Found  
UCIP Comments: No pump connection and no closure device found. Pipe needs to be closed and abandoned properly. Notes in levee log indicate that this pipe had welded steel plates but none were found on pipe ends.  
FIELD\_STRUCT\_DESC: 12-inch asphalt wrapped steel irrigation pipe with pipe sleeved through it through the levee, 4 feet below the crown. Pump components on concrete pad on the waterside (WS) slope. Siphon breaker on landside (LS) slope is missing. Remnants of a 36-inch concrete pipe riser on the LS toe. One corrugated metal cutoff wall. 2-inch galvanized steel electrical conduit through the levee, at an unknown depth, to a joint pole (JP) on the LS. [Additional Reference(s): DWR Levee Log, 1991. USACE Sacramento O&M Manual 111, May 1959, (RM 37.32), listed as a 6-inch pipe, 6.7 feet below the crown].

Concrete pad for missing pump on WS slope. 2-inch galvanized electrical conduit in foreground.

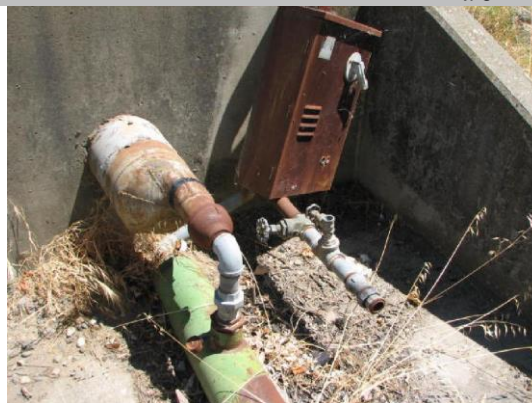
Photo 2 of 3 : UCIP\_FA\_2019\_5311\_7293.jpg

12-inch pipe with 4-inch attachment or sleeved through. Fuse box.

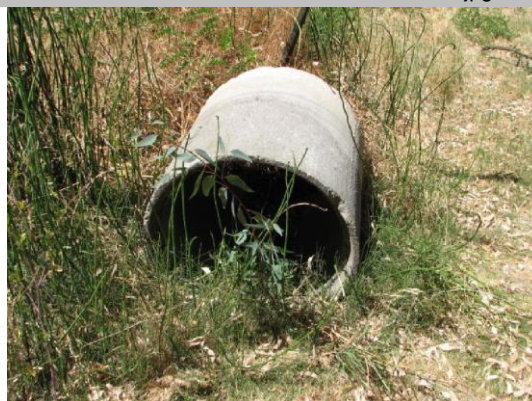
Photo 3 of 3 : UCIP\_FA\_2019\_5311\_7295.jpg

Remnants of 36-inch concrete standpipe on LS toe.

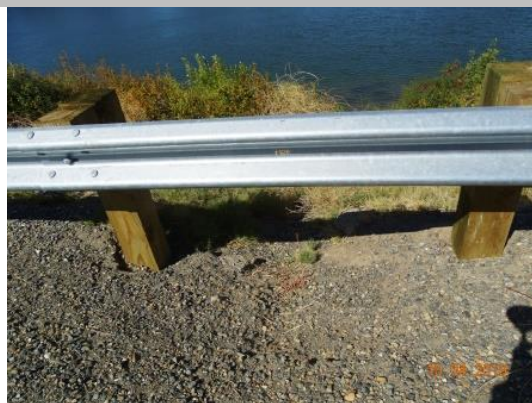
Photo 1 of 1 : FA\_2019\_MA0009\_201\_315\_20191010\_00548.jpg

LM Start	18.63	Rating **	M	Issue No.	315
LM End	18.63	Issue Type +	Ma	Location *	WS
Category	Earthen Levee			GPS Latitude/Longitude	
				Start	End
Item	Erosion / Bank Caving			38.355026 °	38.355026 °
				-121.528077 °	-121.528077 °
DWR ID	DWR_MA0009_01_s_2017_315				
Comment Code					
E1 : Note and monitor erosion site.					
Inspector Comment					
Repair runoff erosion at waterside hinge point.

View of erosion at hinge point. Fall 2019
